Conference on sustainable renovation models
 Parallel Sessions - Part II
 2b) Reducing the costs of the renovation projects

Buy - Retrofit - Sell - a simple game?

REFURBISHMENT OF THE BUILDING TXABARRI 25-27-29-31

BUILT IN 1890

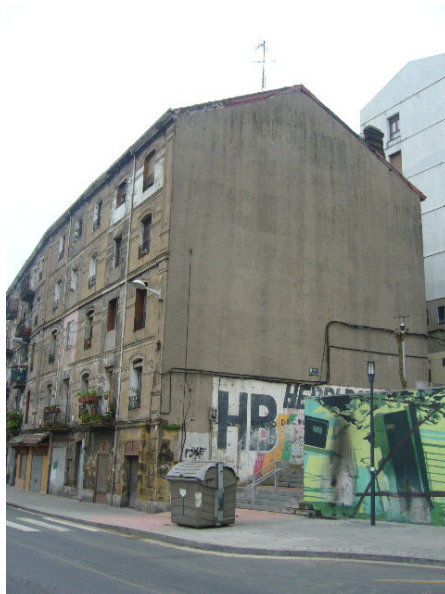
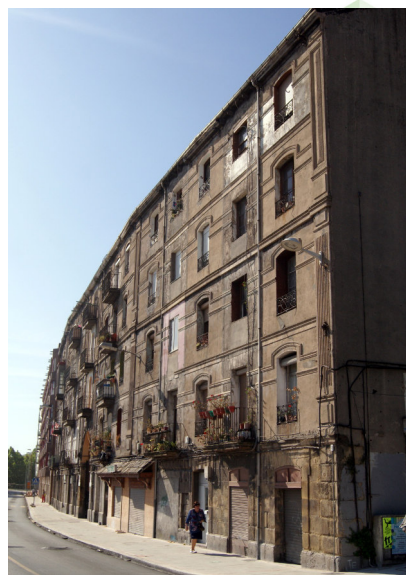
ORIGINAL STATE OF THE BUILDING

ORIGINAL CONSTRUCTION

Year of construction: 1890

4 portals: Tx 25: 11 dwellings
Tx 27: 12 dwellings
Tx 29: 10 dwellings
Tx 31: 10 dwellings

Builted surface: 4.300 m² (58x14 m). **B+4+BC**

Structure: Bearing walls and wooden porches

Envelope: brick facade of variable thickness (46 and 28 cm)
and wooden roof. Wooden windows with single glazing..

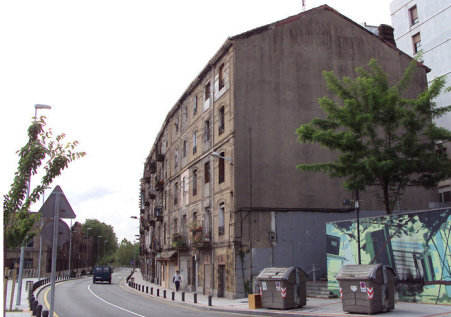
BEFORE

These are some of the **energy efficiency measures** taken for the refurbishment of this building Txabarri 25-31:

- Maintenance of the wooden structure with recycled materials.
- Thermal insulation in the enclosure
- Installation of a biomass boiler for domestic hot water and heating.
- Reduction of the energy demand with mechanical ventilation and heat recovery.
- Grey water recovery.
